Available online at www.sciencedirect.com
ScienceDirect
Nuclear Physics B (Proc. Suppl.) 158 (2006) 195–198
NUCLEAR PHYSICS B PROCEEDINGS SUPPLEMENTS
www.elsevierphysics.com

On aging problem of glass Resistive Plate Chambers

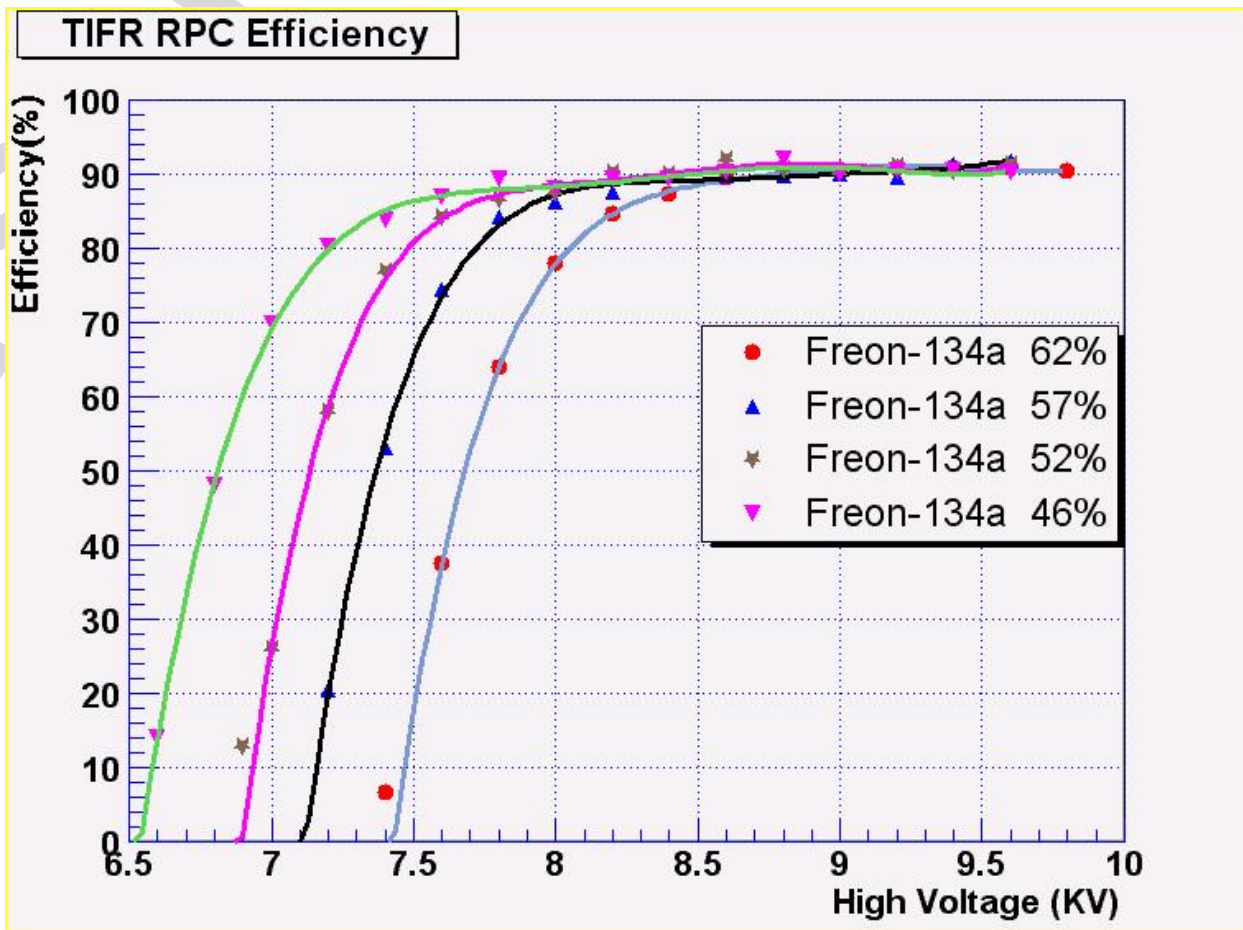
Figure 2. Efficiency plateau plots obtained for various gas mixtures

The first encounter we had with the aging problem was when we operated the RPC, results of which are shown in Figs. 2 and 3, continuously for a few months. We had noticed that, while its efficiency dropped suddenly, the noise rate and chamber current have shot up. The chamber could not be revived. The problem was identical to that reported in the literature [2,3]. The chamber was broken open and the inner surfaces of the electrodes were scanned under Atomic Force Microscope (AFM) [4] and Scanning Electron Microscope (SEM). Shown in Fig. 5 are pictures of two (anode and cathode) damaged electrode and raw glass surfaces.

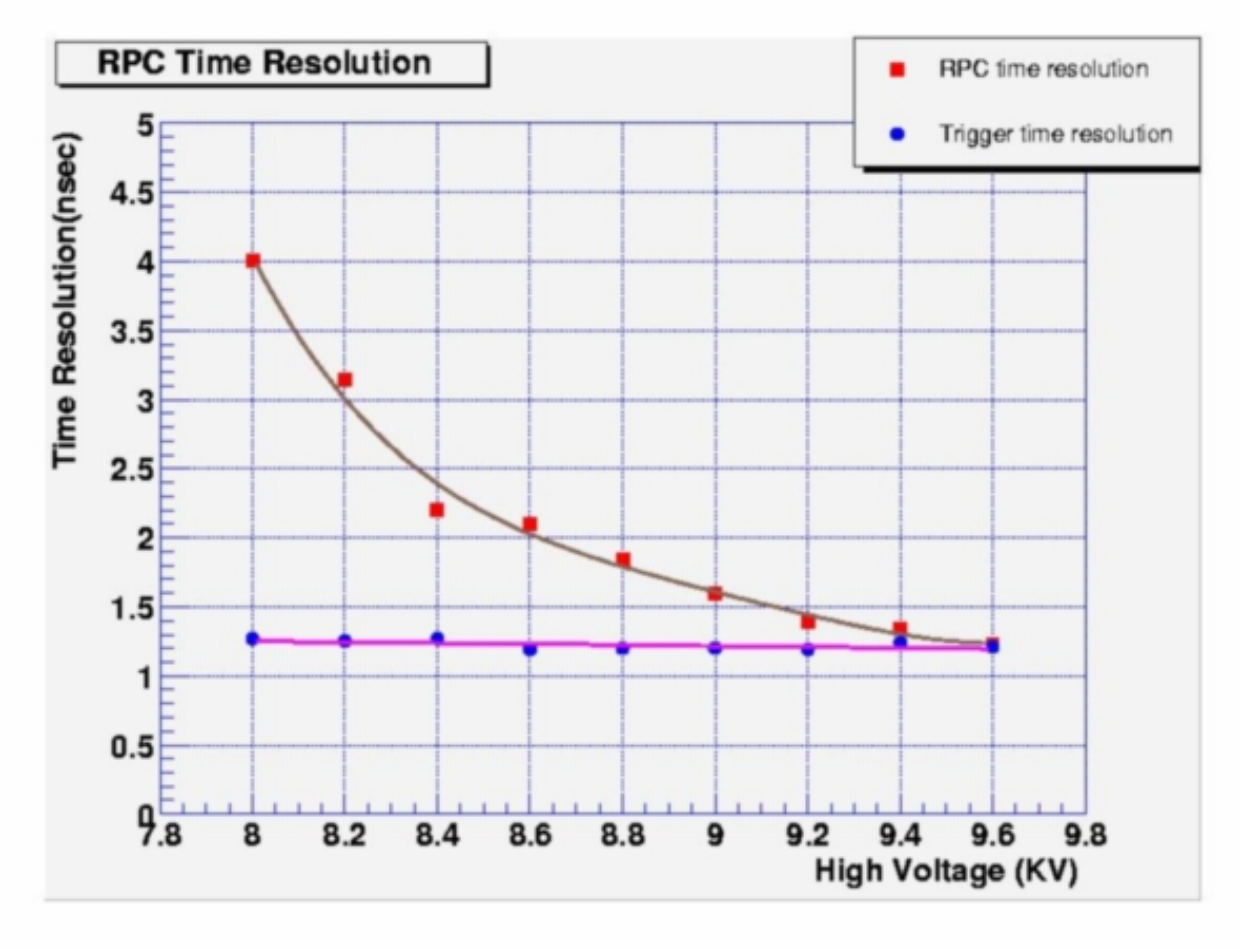
Measurements of the charge linearity and time response of the RPC as a function of applied High Voltage have been made. The typical time resolution, σ, of the RPC when operated in the High Voltage plateau is about 1.2 ns (Fig. 3). The

Figure 3. Timing resolution plot of the RPC

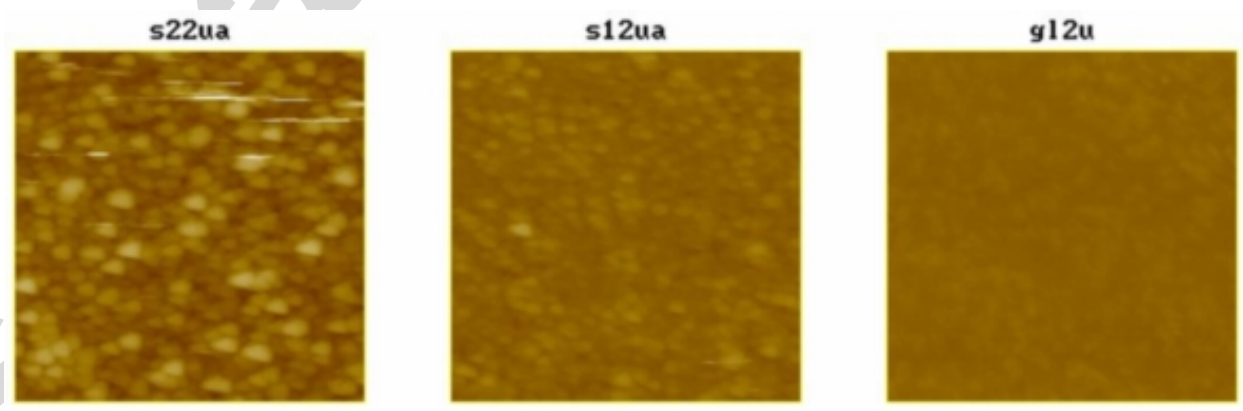
Figure 5. AFM scans of damaged anode, damaged cathode and a raw glass sample

ple, results of which are shown in Fig. 7 and the inset tables. The structures shown in the AFM and SEM scans were found to be rich in Fluorine, confirming the reasoning that Freon (R134a) gas contaminated with moister forms Hydro Fluoride (HF), which actually damages the RPC.

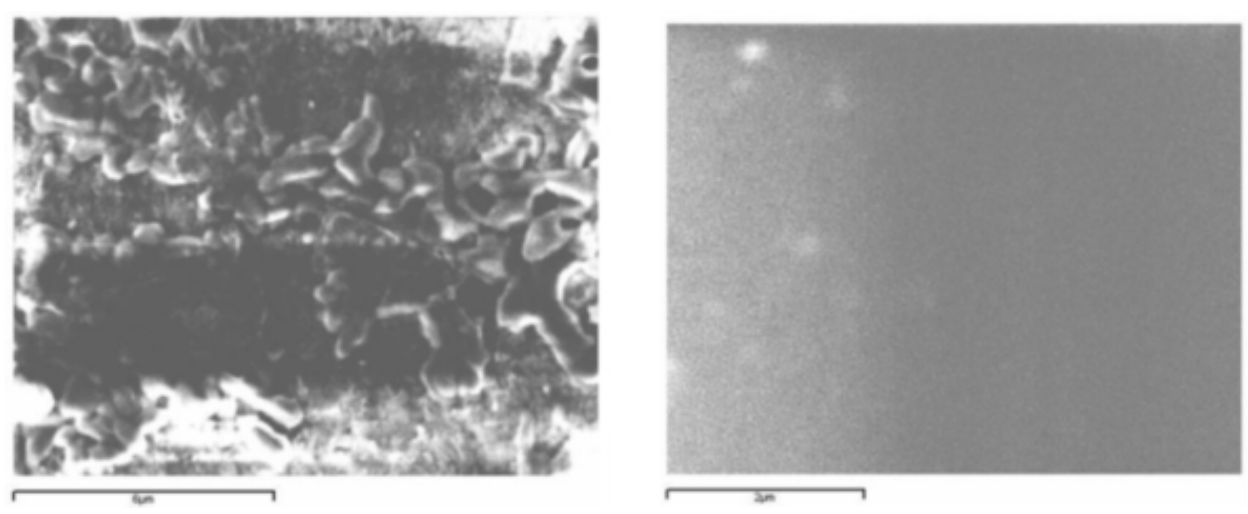
Figure 6. SEM scans of damaged electrode and a raw glass sample

The SEM images of the same damaged electrode and a raw glass are shown in Fig. 6.

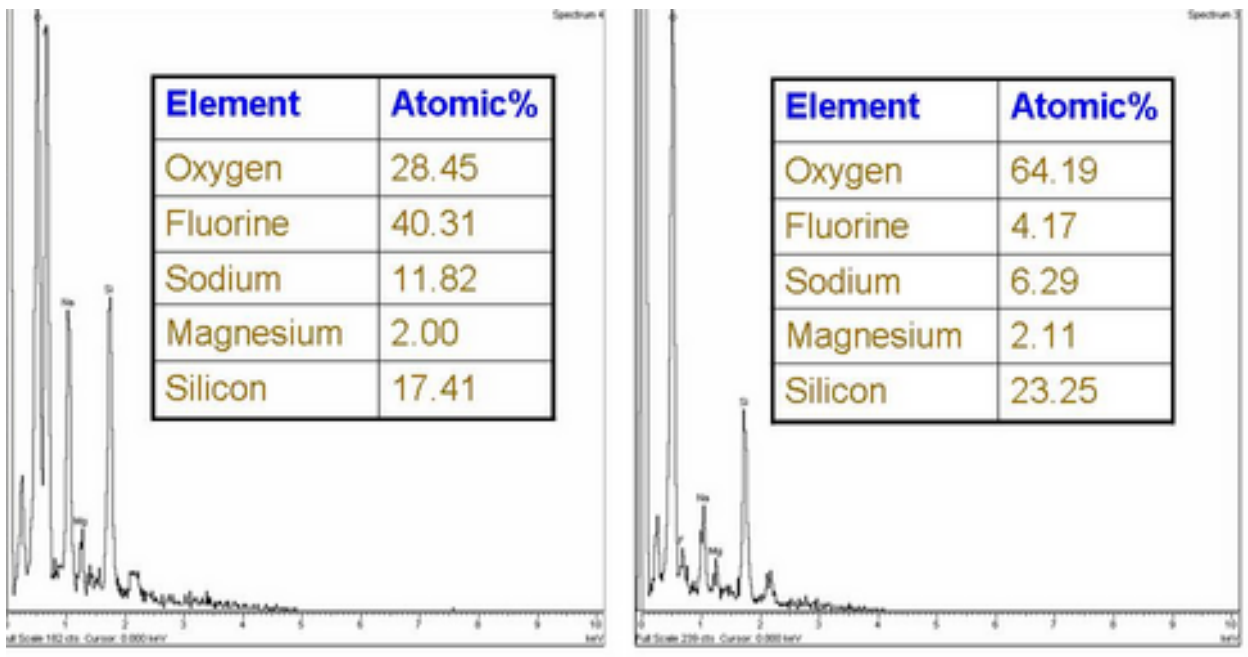
Figure 7. Element analysis of a damaged electrode and of a raw glass sample

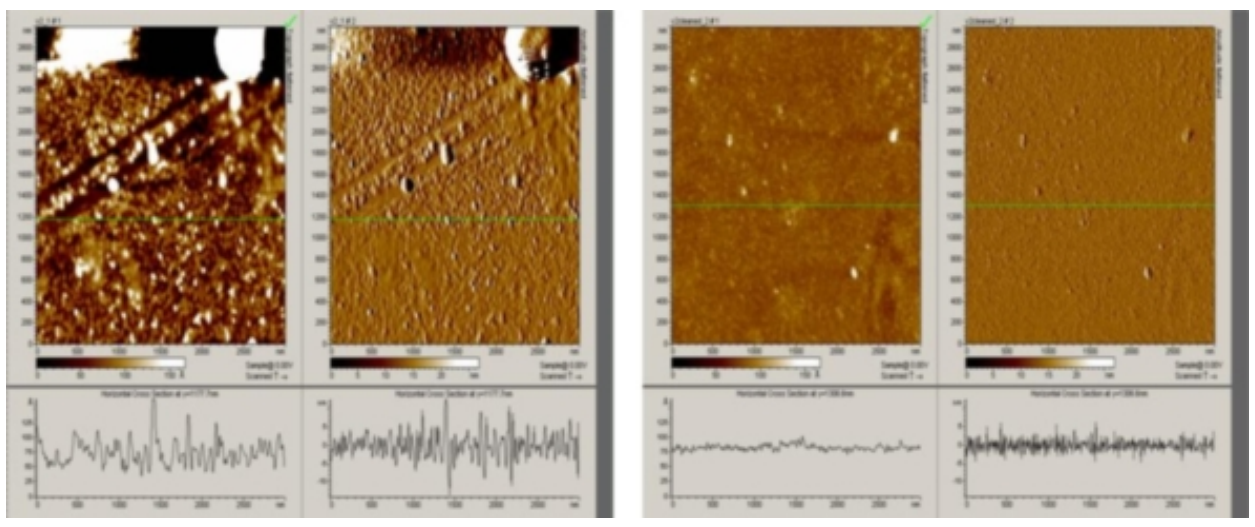
Figure 8. AFM images of a damaged and cleaned electrodes

The structures on the damaged electrodes were found to be loose deposits on the electrodes rather than permanent damaged regions on the glass. This was demonstrated by the AFM images shown in Fig. 8. On the left plate, we have shown the damaged surface, while on the right, we show the same sample which was wiped clean by a dry rough tissue paper.

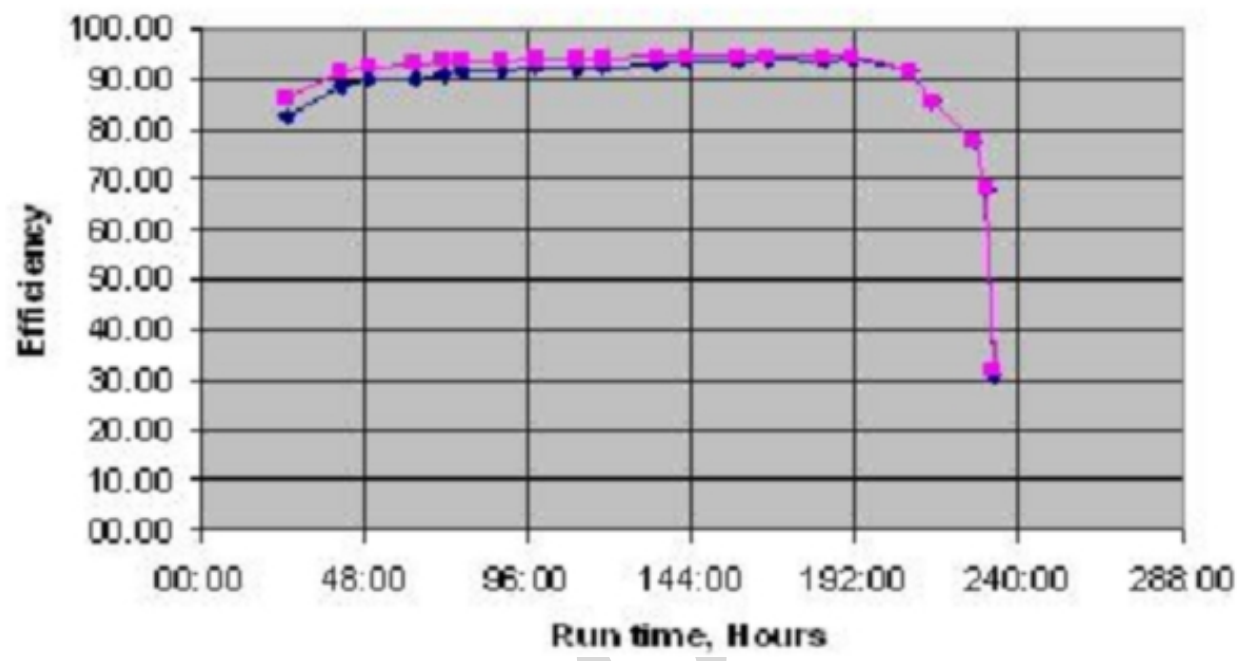
Figure 9. Efficiency drop of an aging RPC

drastic improvement with regard to the aging of the chamber. Shown in Fig. 9 is an efficiency monitor for about last 10 days of a RPC before getting damaged.

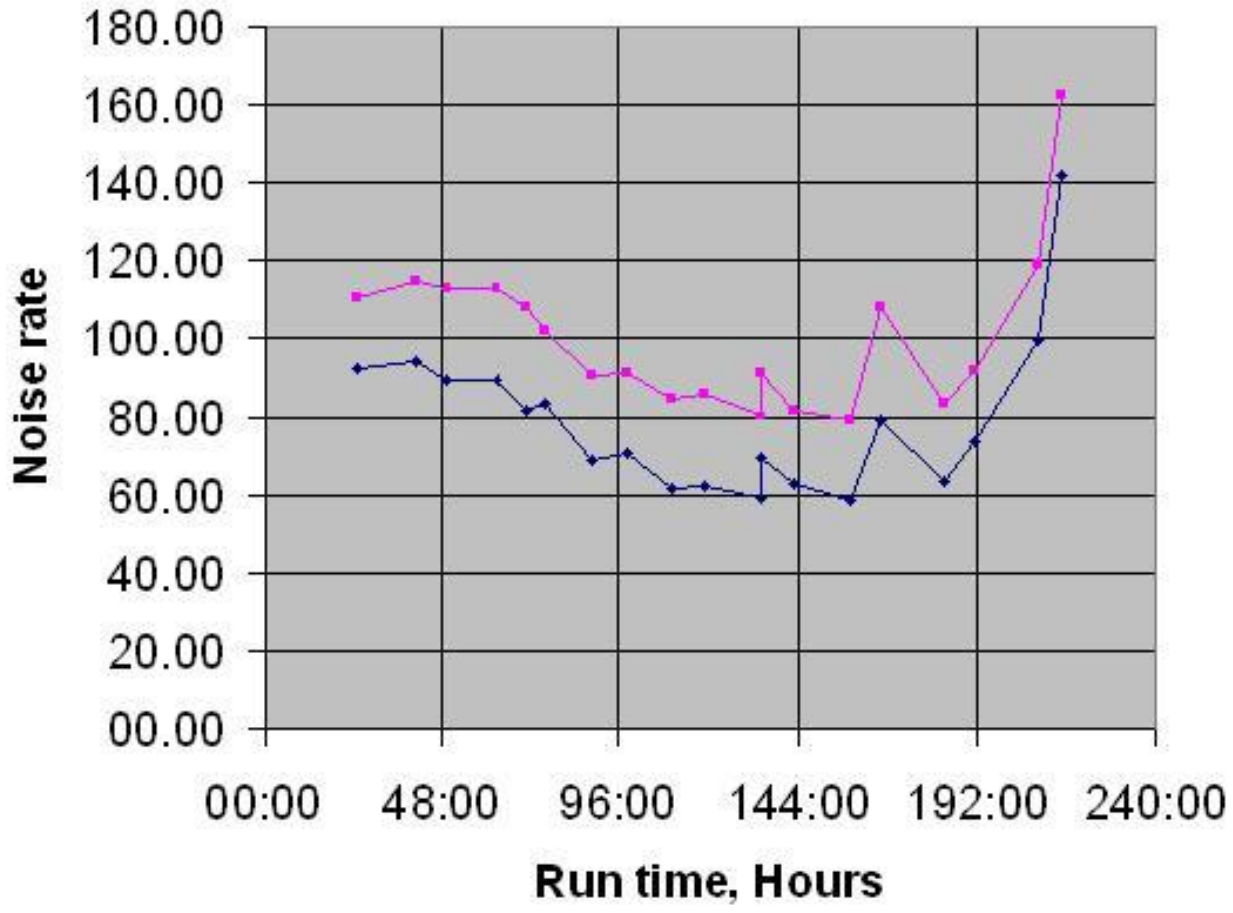
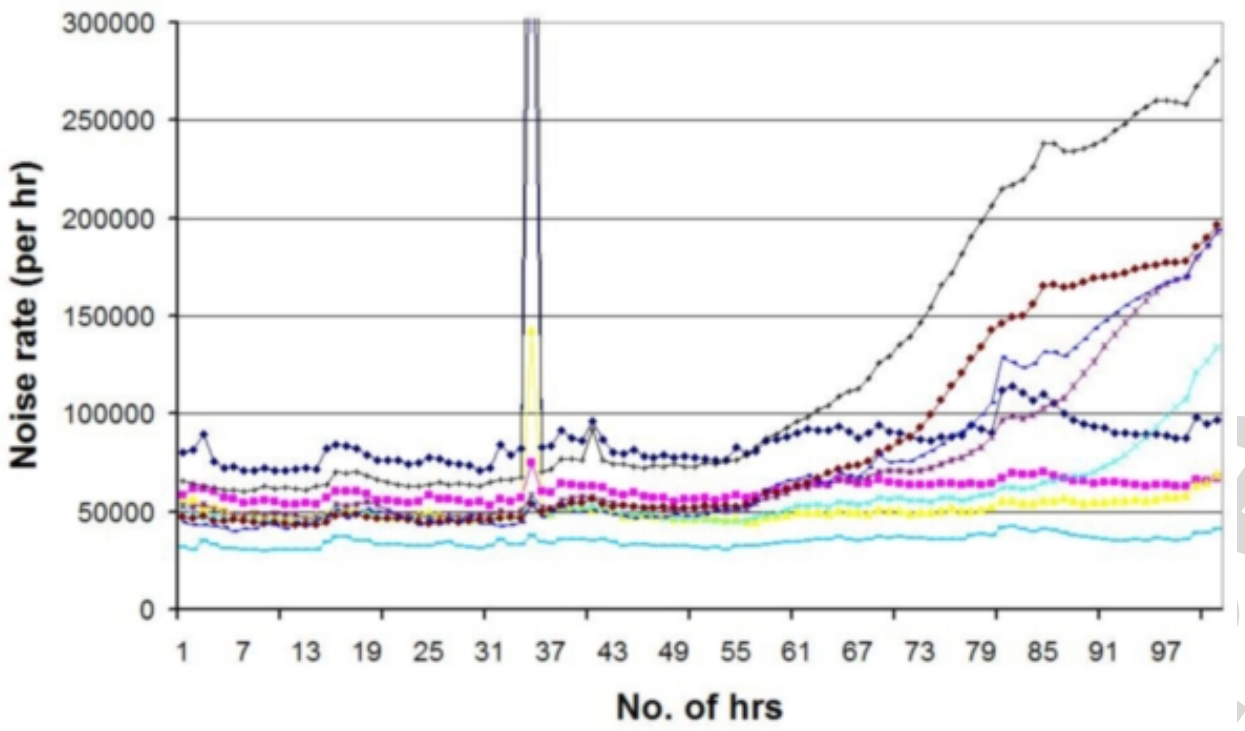
Shown in Fig. 10 and Fig. 11 are the noise rate history of the RPC and its individual strip rates respectively. We see from the Fig. 11 that the increase in the noise rate is not a local phenomenon.

Figure 10. Noise rate history of the RPC

Figure 11. Individual strip rates of the RPC

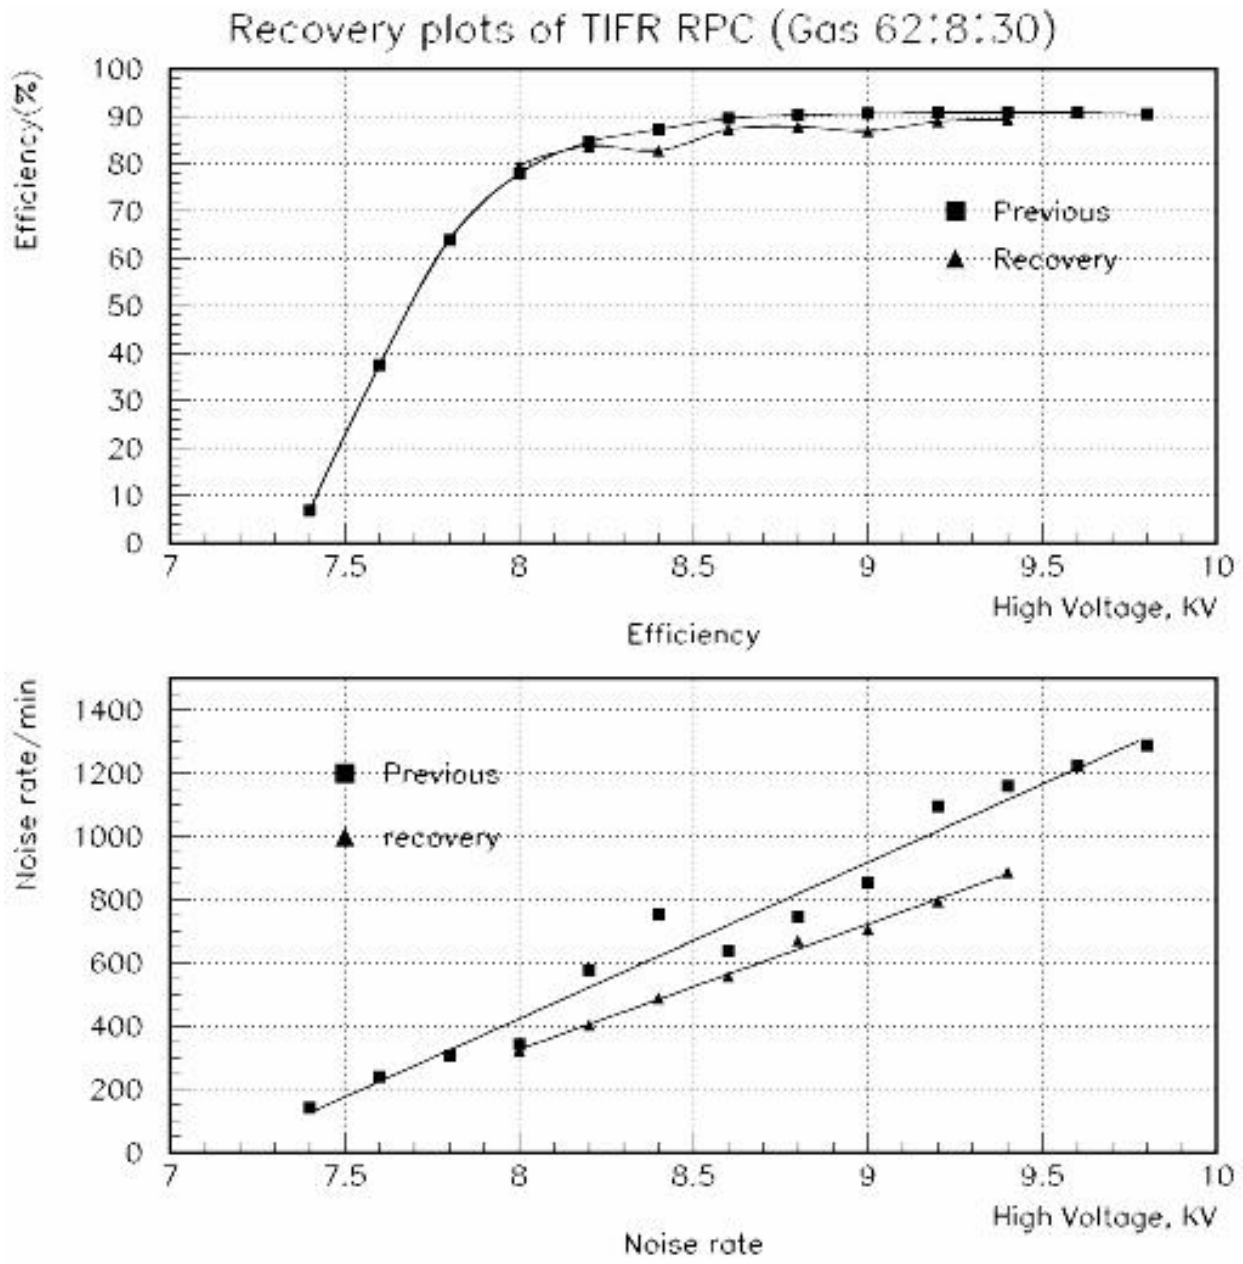
Figure 12. Efficiency (top) and noise rate (bottom) recovery of a damaged RPC

Following the recipe suggested by H.Sakai et al [2], i.e. purging the damaged chamber by pure Argon bubbled through 25% Ammonia solution for 24 hours without electric field, we could recover the efficiency and brought down the noise rate. In Fig. 12, we show the recovery characteristics of this chamber. However, the chamber did not sustain the recovery for long time later.
